Quality Assurance and Source Inspection

Contract #: 04-0120F4Cty: SF/ALA Rte: 80 PM: 13.2/13.9File #: 69.28**WELDING INSPECTION REPORT****Resident Engineer:** Siegenthaler, Peter**Address:** 333 Burma Road**City:** Oakland, CA 94607**Report No:** WIR-021262**Date Inspected:** 05-Jul-2010**Project Name:** SAS Superstructure**OSM Arrival Time:** 700**Prime Contractor:** American Bridge/Fluor Enterprises, a JV**OSM Departure Time:** 1900**Contractor:** Zhenhua Port Machinery Company, Ltd (ZPMC), Changxing Island **Location:** Shanghai, China**CWI Name:** Li Yang**CWI Present:** Yes No**Inspected CWI report:** Yes No N/A**Rod Oven in Use:** Yes No N/A**Electrode to specification:** Yes No N/A**Weld Procedures Followed:** Yes No N/A**Qualified Welders:** Yes No N/A**Verified Joint Fit-up:** Yes No N/A**Approved Drawings:** Yes No N/A**Approved WPS:** Yes No N/A**Delayed / Cancelled:** Yes No N/A**Bridge No:** 34-0006**Component:** OBG Segment Assembly**Summary of Items Observed:**

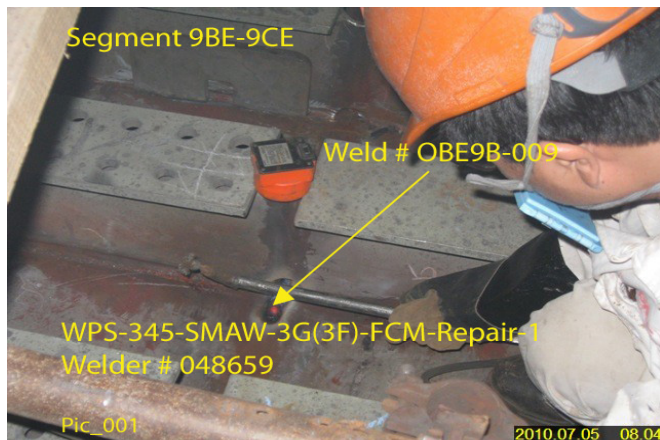
OBG Segment 9BE-9CE

Shielded Metal Arc Welding (SMAW) in the 3G position of Side Panel repair area at Bike Path side, weld joint OBE9B-009 as per repair report # B-WR-13917. The welder is identified as 048659. ZPMC Quality Control (QC) is identified as Wang Li Yang. The welding variables recorded by QC appeared to comply with WPS-345-SMAW-3G(3F)-FCM-Repair-1. See attached photograph Pic_001

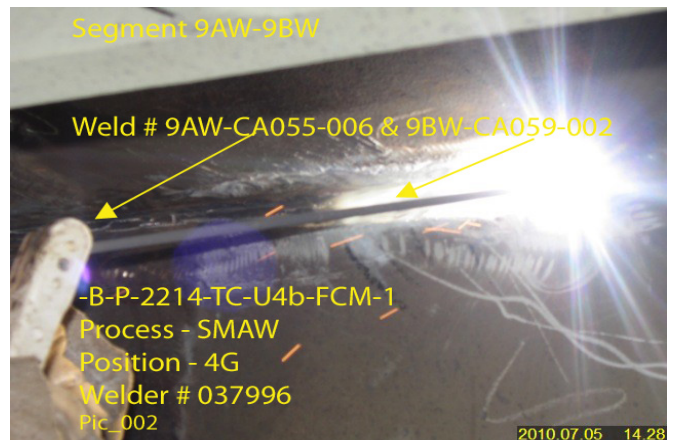
OBG Segment 9AW-9BW

Shielded Metal Arc Welding (SMAW) in the 4G position of Counterweight side Edge Panel to Side Panel hold back area from inside, weld joint 9AW-CA055-006 & 9BW-CA59-002. The welder is identified as 037996. ZPMC Quality Control (QC) is identified as Shi Lei. The welding variables recorded by QC appeared to comply with WPS-B-P-2214-TC-U4b-FCM-1. See attached photograph Pic_002
